# ICE Fimbulisen – Top to Bottom Season 2 Expedition 2010-2011

## **Field Report**

Version 1.1 July 2, 2011

This report outlines the fieldwork and scientific activities at Fimbulisen (ice shelf) during the austral summer 2010-2011, and presents some useful experiences we had during the season.

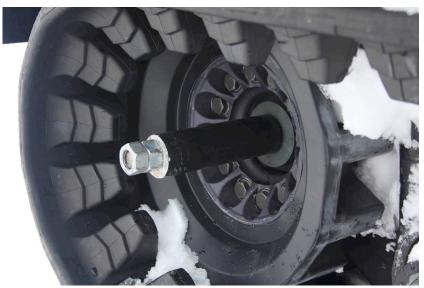
- An oil pressure problem appeared on Sembla a few days prior to departure, and was deemed serious enough to warrant an engine replacement.
- Jack stopped just 10 km out of Troll, because several essential actuators were missing. Spares were brought out from Troll immediately.
- Sembla lost a sprocket wheel near M2 when the centre bolt broke. We had no spares, but the mechanic was able to improvise a repair using scavenged parts from the blade mount on Jack.
- Sembla suffered persistent engine performance problems at Jutulstraumen. After several consultations with Berco and Cummins a disengaged air intake heater was identified as the source of the problem, and fixed.
- Immediately before arrival at Troll Station on January 5 it became clear that the forward differential gear on Jack was about to break down.

Figure 2: The improvised sprocket wheel repair.

After Sembla's drive wheel failure and before the improvised repair we were left with one operational tracked vehicle, possibly not too trustworthy, and two snowmobiles. The need for spare parts led to some delicate considerations regarding supply chain and safety margins. An air drop was considered, but would have required a dedicated and thus expensive Basler flight. Eventually the spare parts were sent from Troll station with the ordinary transport to the ship landing site, and put in a depot at site S53, some 260 km from our camp at M2. At the time we were still weather-bound at M2 and could not rendezvous with the transport from Troll at S53. Given that we would have no more than 3-5 days left at Jutulstraumen when the storm abated we had to consider some thorny options. To make the most of our time we eventually decided that Kjetil and Stein would drive Jack alone from M2 to S53 to pick up the parts, while Kirsty and Elvar would finalize the science programme at Fimbulisen by driving the last 160 km loop with the two snowmobiles. In the not too unlikely event of Jack breaking down somewhere between M2 and S53, this could have put us in a difficult position. Kirsty and Elvar might have had to cross the unmarked shear zone on snowmobiles to assist, without a crevasse radar, or a support team might have been compelled to do the same thing with snow groomers. Fortunately the contingency dissipated when Sembla was repaired on site.

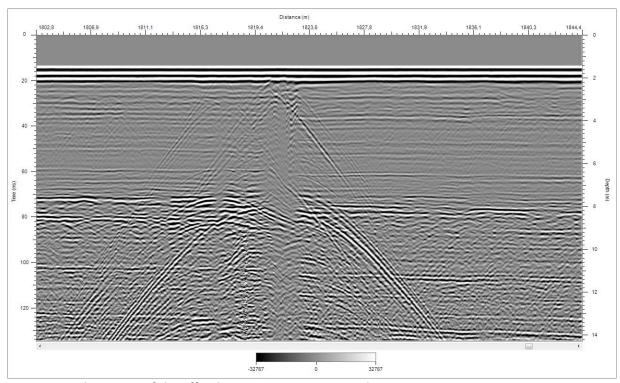
When returning from Jutulstraumen on Christmas Eve, we approached the mentioned crevasse "breeding ground" carefully. The radar images appeared very similar to those seen in November, and believing the wider crevasse still to be narrow enough for safe crossing, we proceeded. Somewhat surprisingly the trailing runners of the living module sledge penetrated the snow bridge and revealed an abyss about twice as wide as observed in November. Careful post-examination made it clear that the radar image did indeed point to a

wider crevasse, but the information was difficult to interpret due to a pattern of parallel and much narrower cracks.

Figure 3: Radar image of the offending crevasse, 2-2,5 m wide.

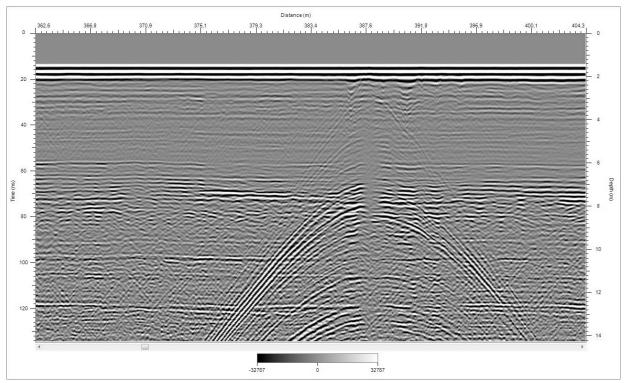
Emerging danger zone: On the route segment between waypoints F14 and F15 we found an area of nascent crevasses. This was rather interesting, as the crevasse radar showed the area to be generally clear of obstacles. While driving westwards on November 28 we found a solitary crevasse across our track, extending indefinitely towards the north and south. The crevasse was about 1 meter wide, clearly visible on the surface and the radar signature equally clear, so the obstacle offered no difficulty or safety problem. However, on the return journey on December 24 another little crevasse had cracked open about 1,5 km further west – clearly visible on the radar and on the surface, but only 10 cm wide. At the same time the original crevasse had widened to over 2 meters. Later parties should remain observant while passing this area.

Figure 4: Radar image of the newly formed crack, 10-20 cm wide.

- Do not travel unscouted routes in poor visibility.
- Keep an eye open for widening crevasses east of F15
- Ideally crevasse zones should only be negotiated in excellent visibility
- ~ Flag marking of difficult exit/supply routes is recommended.
- Save the GPS track log of the last vehicle to cross difficult ground (can be emailed to relief parties), while bearing in mind that the Jutulstraumen flows dozens of metres seaward during a season.
