RAPPORTSERIE

Nr. 45 - Oslo 1988

ANNA KRZYSZOWSKA:

**Human impact on the tundra environment
at Ny-Ålesund, Svalbard**

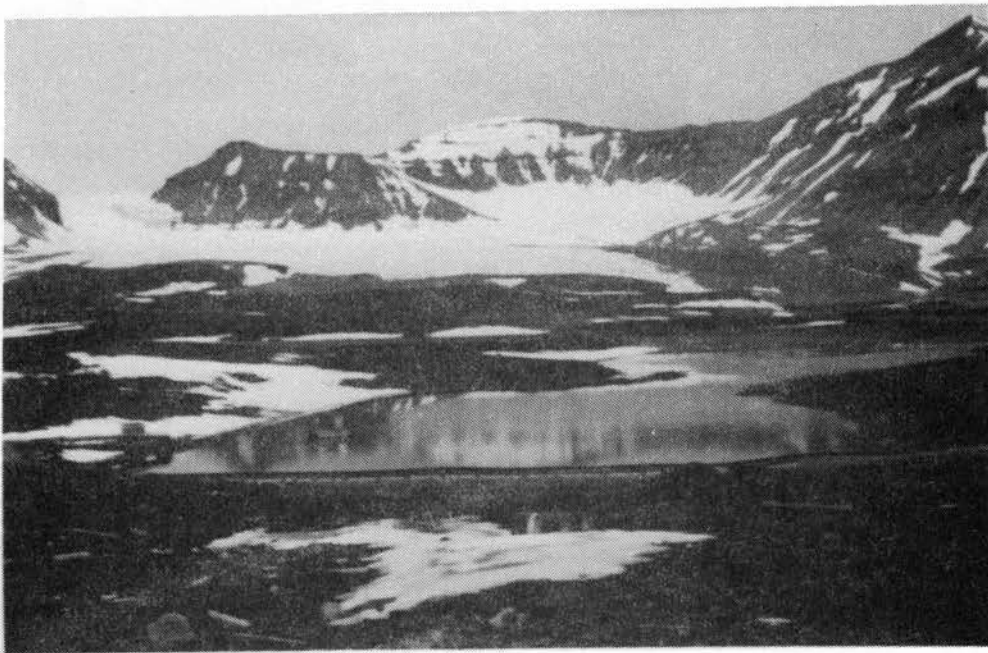
Photo 1. Lake Tvillingvatnet with potable water

Water for Ny-Ålesund is pumped from Lake Tvillingvatnet (photo 1) located 1.3 km from the first buildings and it is distributed through a 2 km utilidor system which also contains heating and sewage pipes. Liquid sewage is drained off immediately into the sea, (photo 2) solid

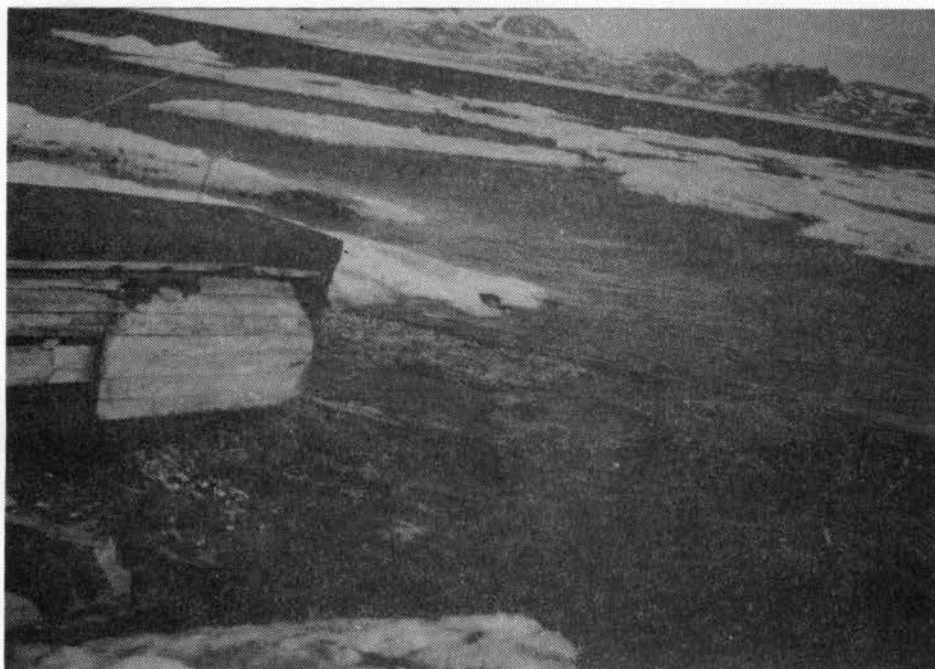
Photo 2. Outlet of sewer ditch.

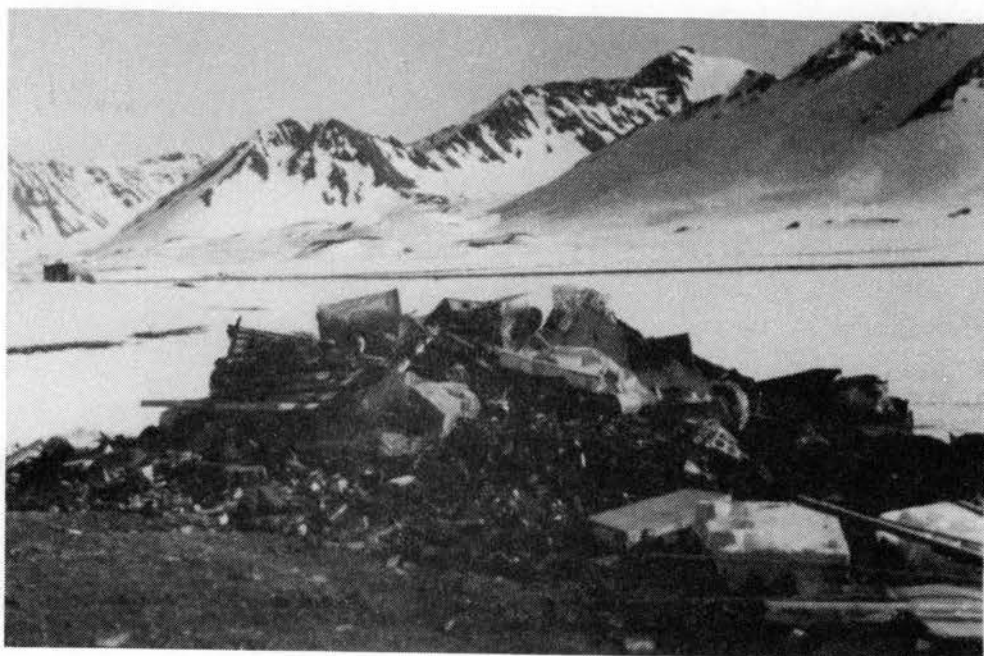
Photo 3. Solid waste dump.

wastes are gathered in "honey-bags" and carried away to refuse dumps to be burned periodically (photo 3).

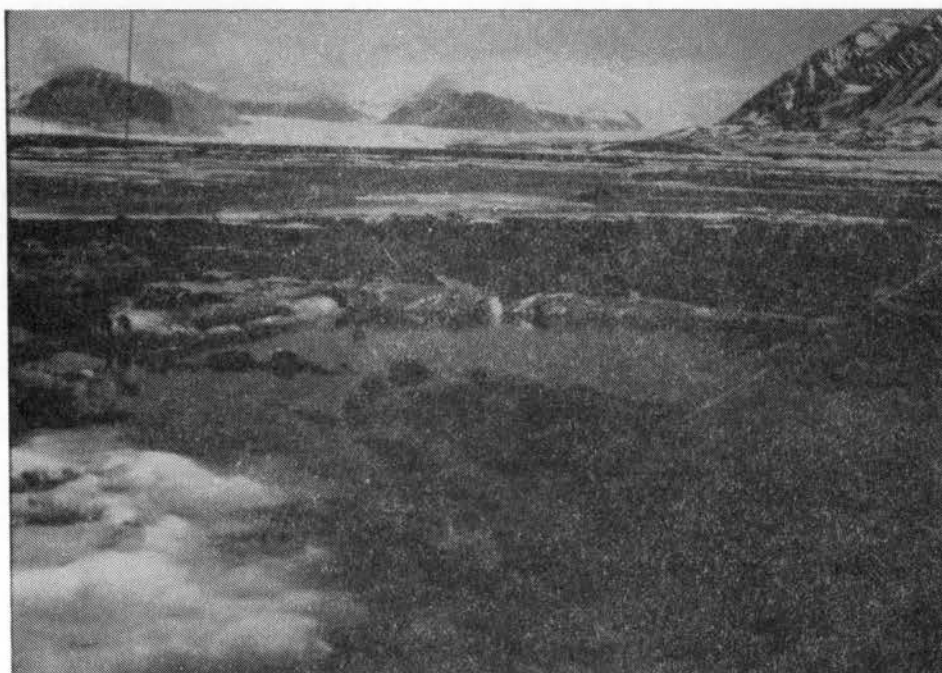
Photo 5. Oil trap on stream flowing into the Solvatnet pond.

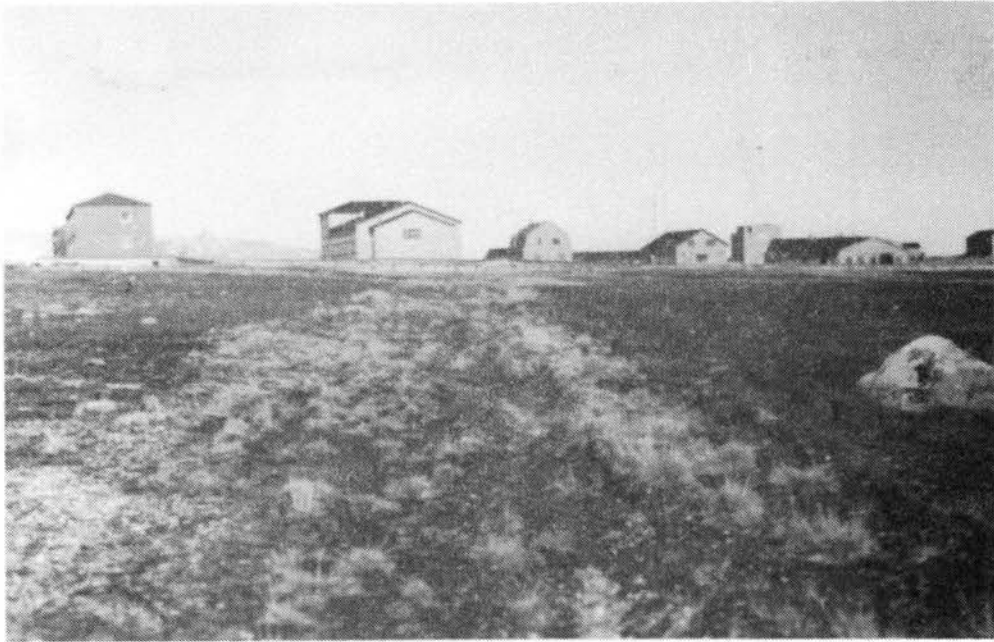
Photo 7. Road with tussocks of *Deschampsia alpina* at cross-section no.1
