Local contamination in Svalbard

Overview and suggestions for remediation actions

Kortrapport/Brief Report no. 044

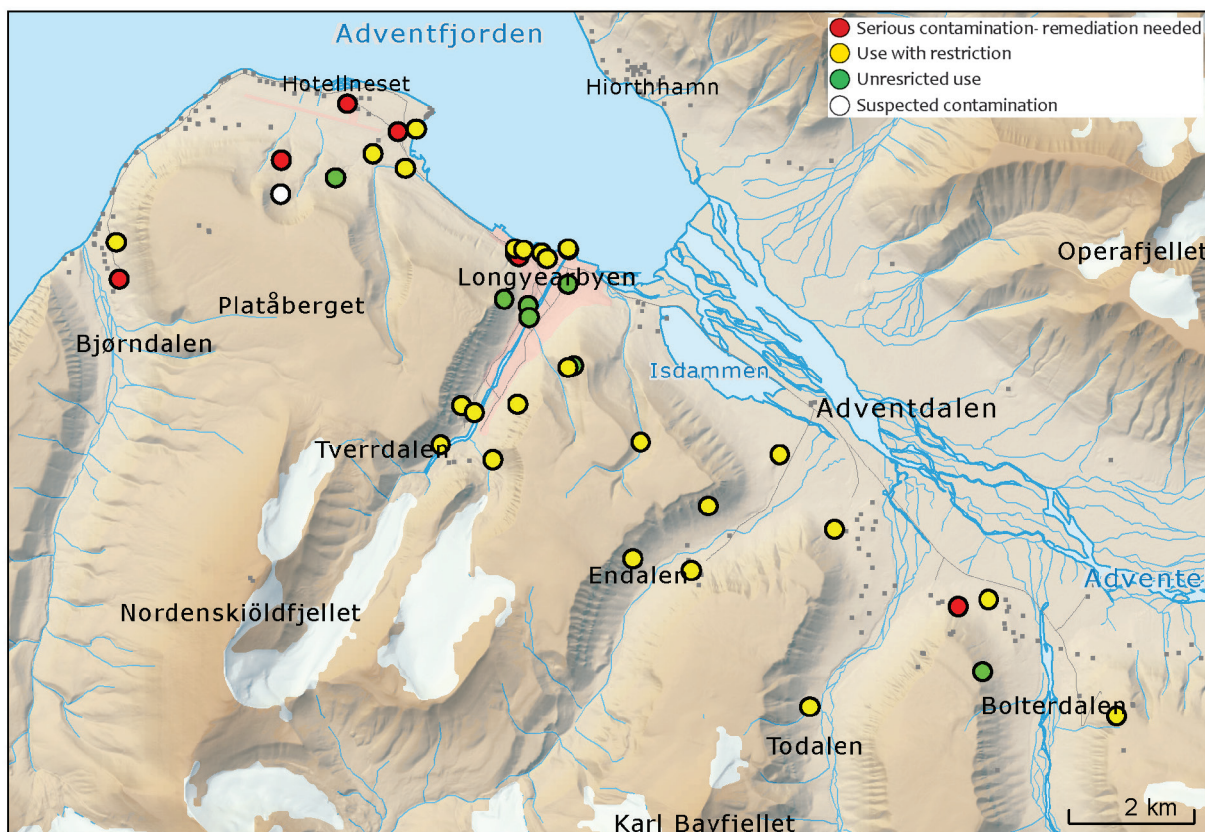
Figure 2. Longyearbyen with reported contaminated sites, <http://grunn.miljodirektoratet.no/>.

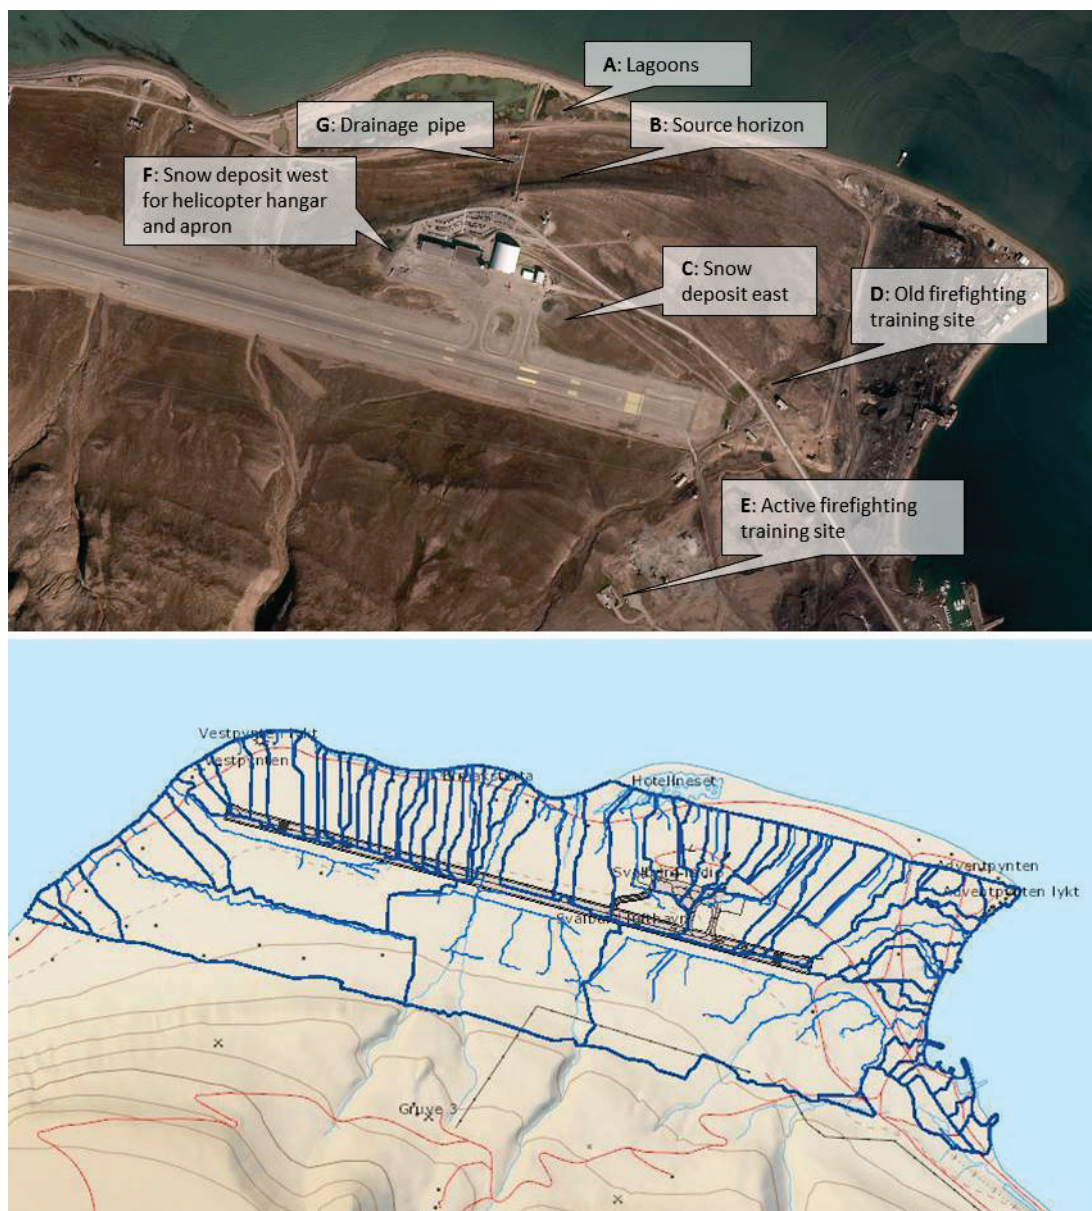
Figure 3. Radar image of the Longyearbyen air- and heliport (top) with some installations and sites associated with handling or storage of hazardous materials indicated: A) lagoons, B) source horizon, C) snow deposit east, D) old firefighting training site, E) active firefighting training site, F) snow deposit west for helicopter hangar and apron, and G) drainage pipe. Radar image courtesy the Norwegian Polar Institute. Bottom map showing land runoff water drainage around the Longyearbyen Airport (Pengerud & Kvisle, 2016).

The Longyearbyen airport is situated on the slope of a moraine. Groundwater drains from the side of the moraine into the Adventfjord. The airport collects part of the drainage water from the working areas and releases it at 18 m depth in the Adventfjord (Fig. 3). A large part of the runoff from the airstrip and working areas does, however, drain directly into the Adventfjord lagoons “Laguner” (Fig. 3-A) and into the fjord itself. The lagoons are frequented by migrating seabirds. Breedveld et al (1999c) reported severe petroleum contamination of soil at the old firefighting training site (Fig. 3-D). This site has mainly been used as an airport firefighting training site. Surface soils also contained degradation products of pesticides (DDT and endosulfan) and PCB. The groundwater at the site was also strongly contaminated with petroleum. The airport has recently been investigated regarding their use and release of contaminating chemicals with particular recent focus on PFCs (Norconsult AS, 2015; Pengerud & Kvisle, 2016; Rudolph-Lund, 2012). PFCs above restricted limits were detected at the old firefighting training site, spreading in an easterly direction. Likewise were PFOS levels exceeding environmental restriction levels at the new firefighting training site, with runoff water containing mainly PFOS (5.5 µg l⁻¹) (Rudolph-Lund, 2012). The most recent environmental assessment of the airport focused on contaminants associated with water runoff draining into the lagoons and Adventfjord (Pengerud & Kvisle, 2016). The investigation showed elevated concentrations of heavy metals, BTEX, THC and PFAS in soil and water samples, indicating that actions should at least be taken to protect adjacent watersheds.

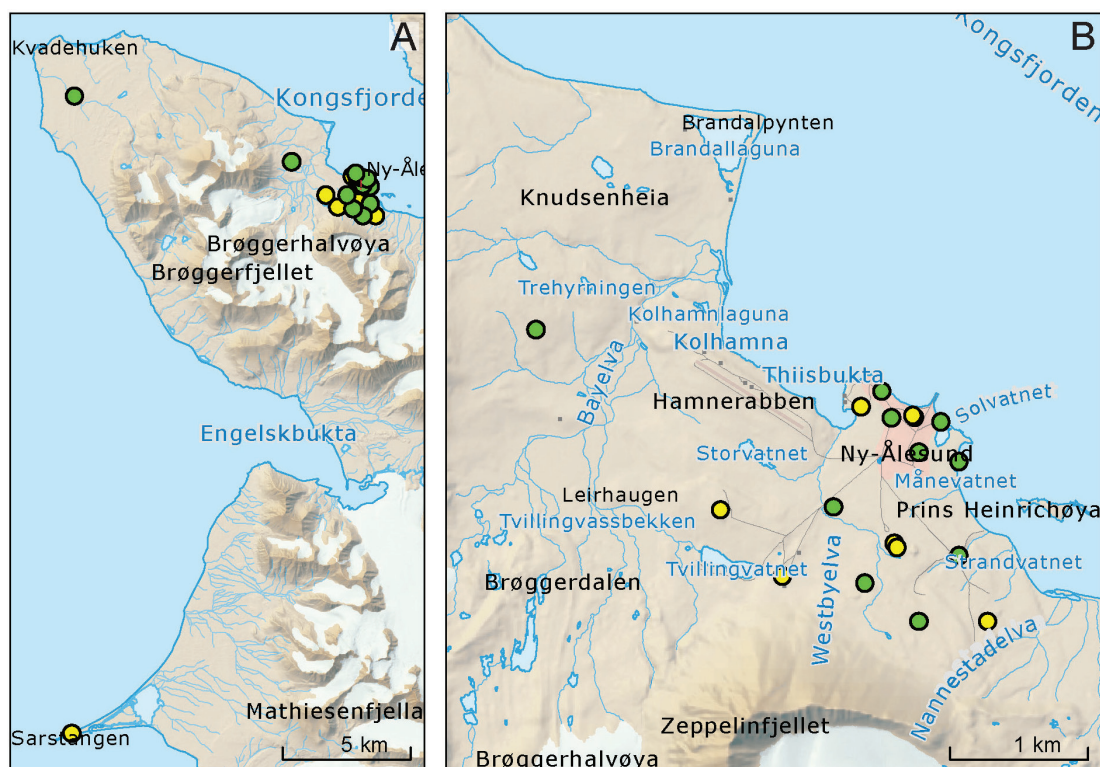
Figure 4. Map of A) Brøggerhalvøya and vicinity and B) Ny-Ålesund showing reported contaminated sites as coloured circles, <http://grunn.miljodirektoratet.no/>. For figure legend see Fig. 2.

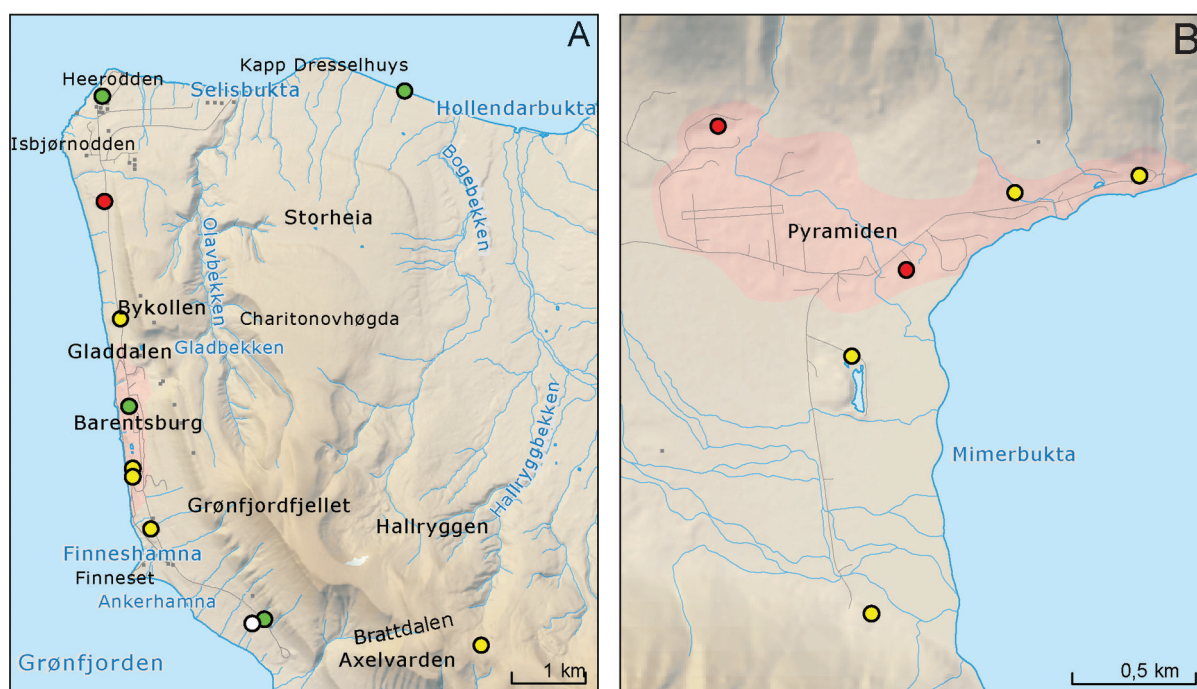
Figure 5. Map of A) Barentsburg and B) Pyramiden showing reported contaminated sites as coloured circles, <http://grunn.miljodirektoratet.no/>. For figure legend see Fig. 2.

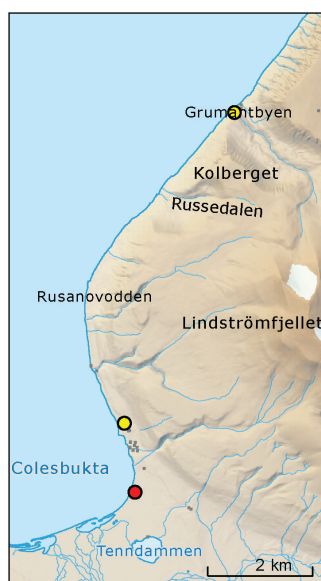
Figure 6. Map of Grumant and Colesbukta showing reported contaminated sites as coloured circles, <http://grunn.miljodirektoratet.no/>. For figure legend see Fig. 2.

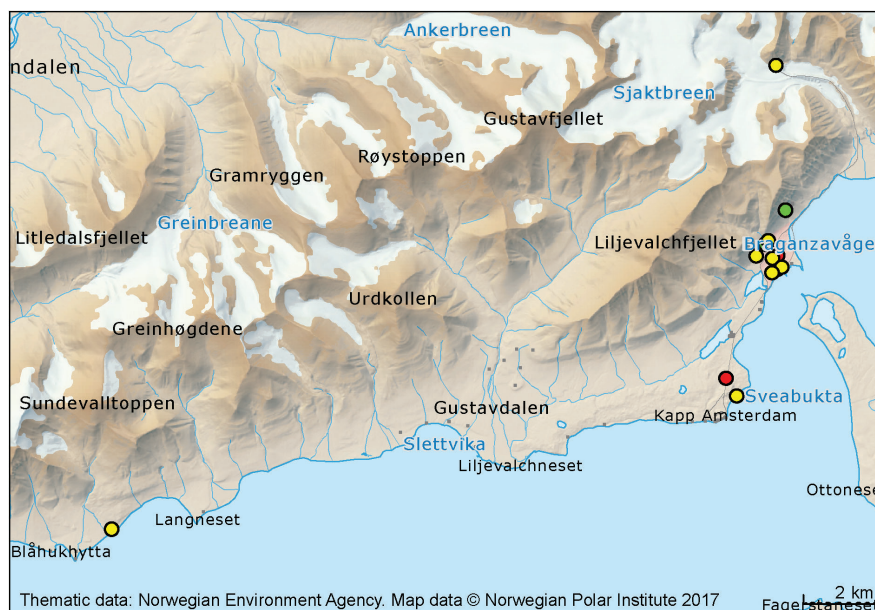
Figure 7. Map of Svea showing reported contaminated sites as coloured circles, <http://grunn.miljodirektoratet.no/>. For figure legend see Fig. 2.

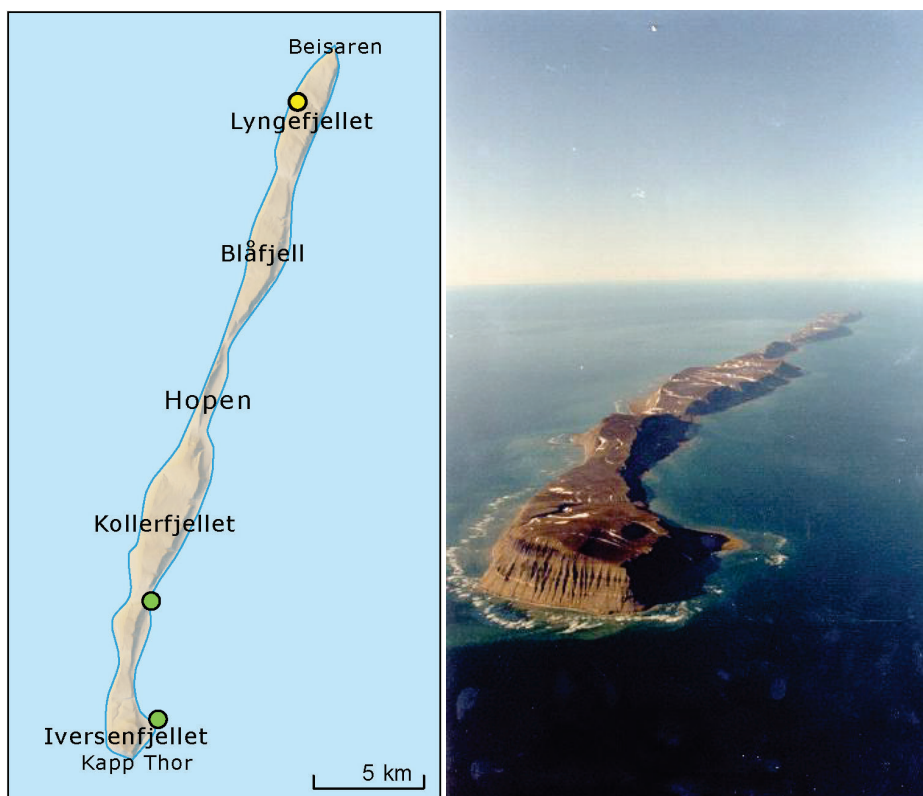
Figure 8. Map and photograph of the island Hopen east of the southern tip of Spitsbergen. Map showing reported contaminated sites as coloured circles, <http://grunn.miljodirektoratet.no/>. For figure legend see Fig. 2. Photograph from the Norwegian Meteorological Institute <http://met.no/Hopen.9UFRjU2F.ips>.

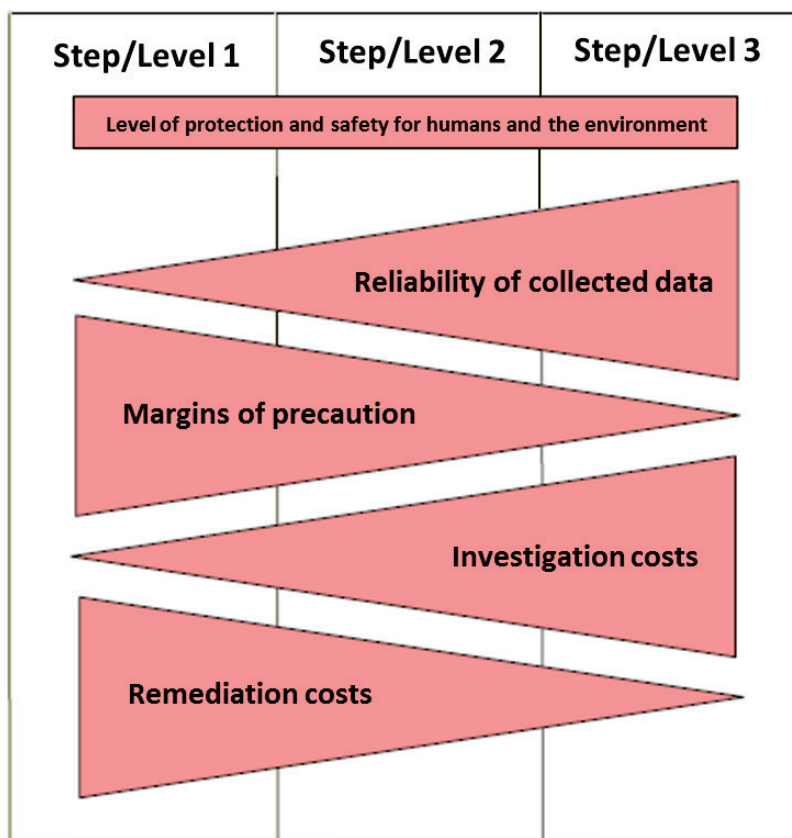
Figure 9. A stepwise structure of the risk assessment procedure aims to enable similar levels of protection for humans and the environment without equal levels of available information or data. Redrawn after Vik et al (1999).

Level 2 - Extended risk assessment (estimated exposure). Exposure routes are identified and worst case scenarios are determined. This involves source, emission, and exposure analysis where episodic events related to seasons (e.g. heavy rainfall, snowmelt) must be included. Acute and chronic exposures are compared to levels of concern and acceptance criteria. Environmental concentrations are also compared to environmental targets. If levels and exposure are exceeded remediation actions must be implemented.

Level 3 - Extended risk assessment (measured exposure). The difference between level 2 and level 3 assessments is that concentrations are actually measured instead of estimated.

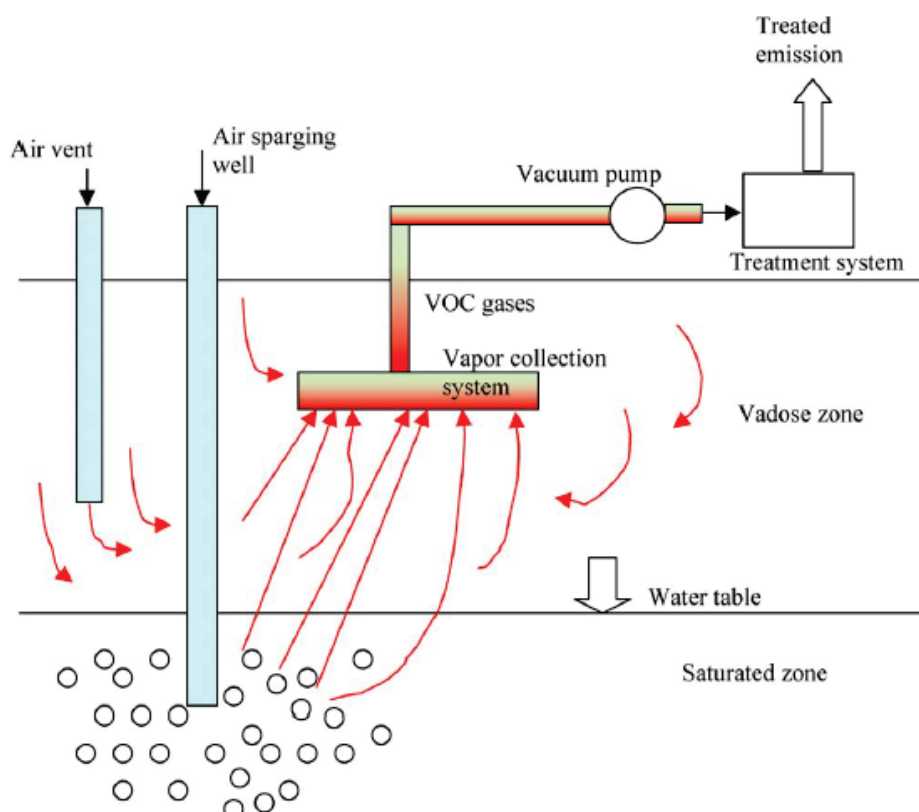
Figure 10: Soil vapour extraction for *in situ* remediation of contaminated soil (Khan et al, 2004).

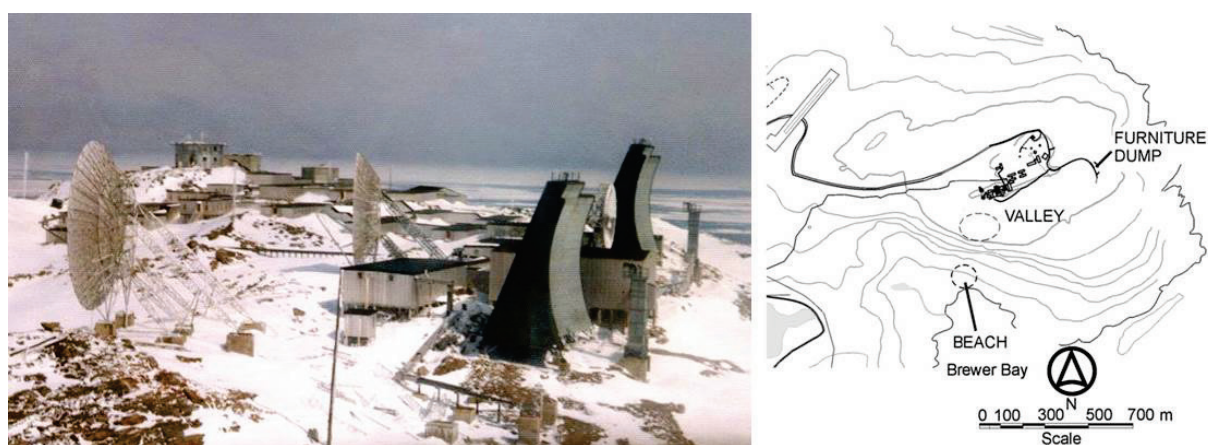
Figure 12. Resolution Island, Nunavut, Canada. Photo courtesy Rob Hopkins. Map of site and drainage barrier sites (Kalinovich et al, 2012).

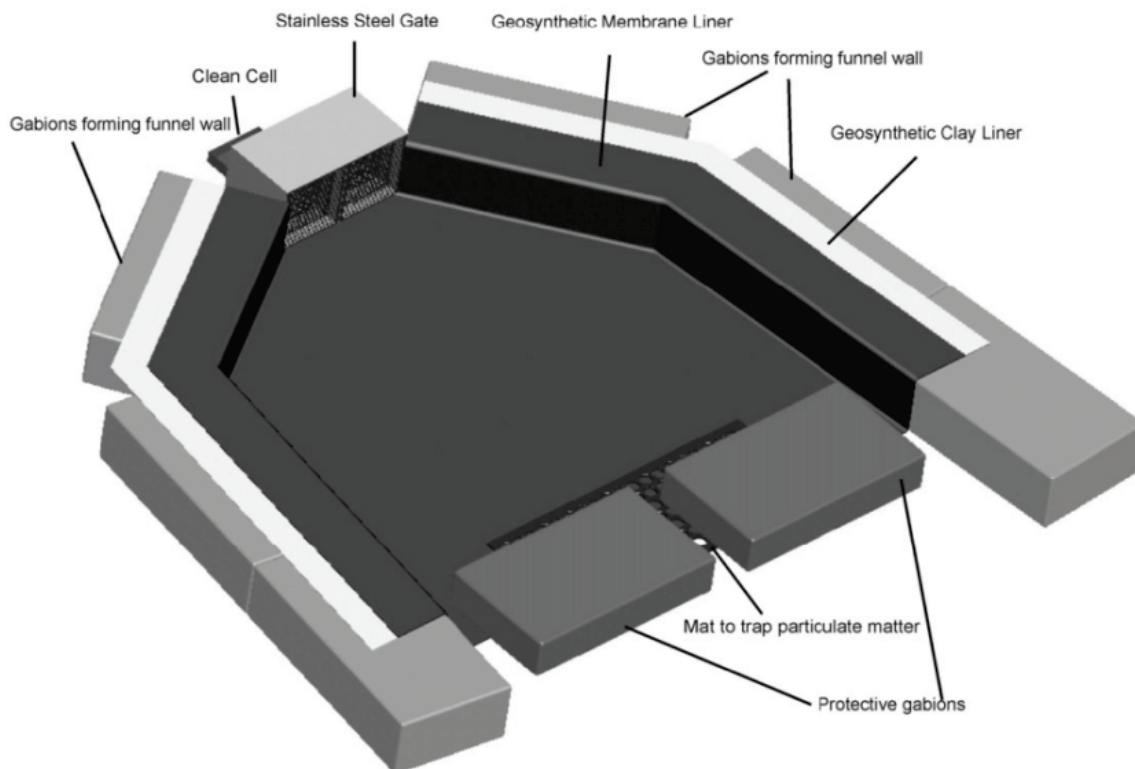
Figure 13. Prototype illustration of drainage barrier at BAF-5, stainless steel gate box dimensions 1,5×0,5 m (Kalinovich et al, 2008).

Due to leakage of PCBs from contaminated soil into the sea, three drainage barriers were designed and installed in the leachate pathways at the valley, beach and furniture dumpsites (Fig. 12). The funnel-like drainage barriers with filters were designed to retain PCB-contaminated particles transported with surface water runoff (Fig. 13). The presence of petroleum products along one of the drainage pathways led to increased transport of PCBs due to their higher solubility in these solvents as compared to water. The drainage barriers were monitored annually after installation, appearing to be highly functional with successful retention of remaining PCB-contaminated particles.

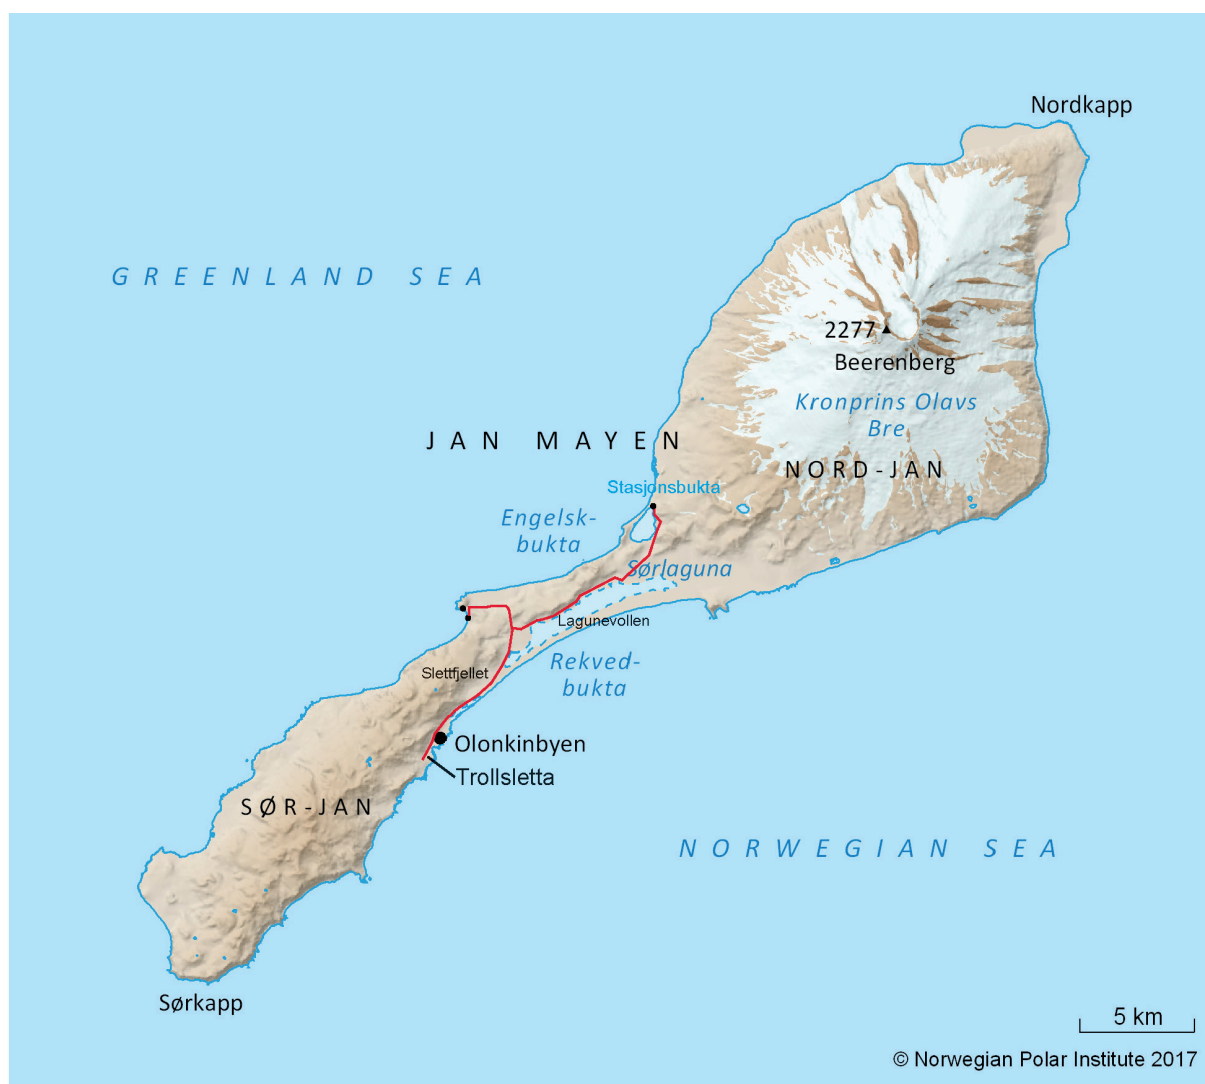
Figure 14. Jan Mayen, Norway with the Trollsletta dumpsite, <http://topojanmayen.npolar.no/>.

In 1993 and 1994 high THC ($13.400 \mu\text{g g}^{-1} \text{DW}$) and PCB ($0.2 \mu\text{g g}^{-1} \text{DW}$) concentrations were detected at the military radar station dumpsite at the settlement Olonkinbyen (Fig. 14). The PCBs originated from transformer oil, which had been deposited at the now closed dumpsite at Trollsletta. The dumpsite is located on a slope, 2-5 m from the sea shore.

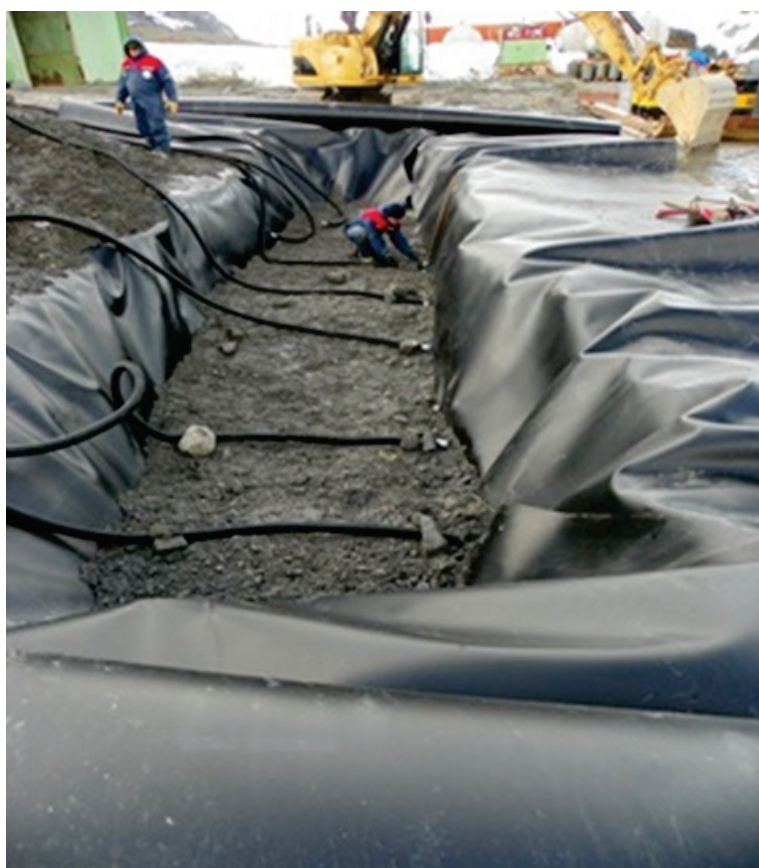
Figure 16. The Brazilian Research Station, Antarctica. Installation of a bioventing system during *in situ* remediation of diesel-contaminated soil using “biocava” techniques (ATCMXXXIX-CEP6, 2016).

Based on recommendations in the Antarctic Clean-up Manual and studies documenting the presence of hydrocarbonoclastic microbes in natural soils from the area (Cury et al, 2011; Cury et al, 2014), augmented *in situ* remediation was chosen as a plausible and cost-effective alternative for diesel clean-up. The clean-up procedures were partly experimental including the construction of a “biocava” and a biopile. Biocava construction was initiated in January 2014 where a large area (264 m²) with contaminated soil was excavated (l: 22 m, w: 12 m, d: 2.5 m). The excavated pit was lined with a geomembrane (high density polyethylene membrane, thickness 2 mm) and supplemented with aeration pipes for bioventing (Fig. 16). The excavated soil was amended with nutrients and loaded back on top of the geomembrane and pipes and covered. Increased oxygenation and nutrient supply was expected to stimulate microbial degradation and mineralization of the soil associated diesel. Biopiling of diesel-contaminated soil excavated from another part of the impacted site was initiated in January 2015. The biopile consisted of 450 m³ of diesel-contaminated soil amended with fertilizers and covered by a geomembrane (ATCMXXXVIII-CEP6, 2015a). Soil sampling is planned to be performed in the beginning and end of each summer season at both bioremediation sites to monitor the progress of diesel biodegradation (ATCMXXXIX-CEP6, 2016).

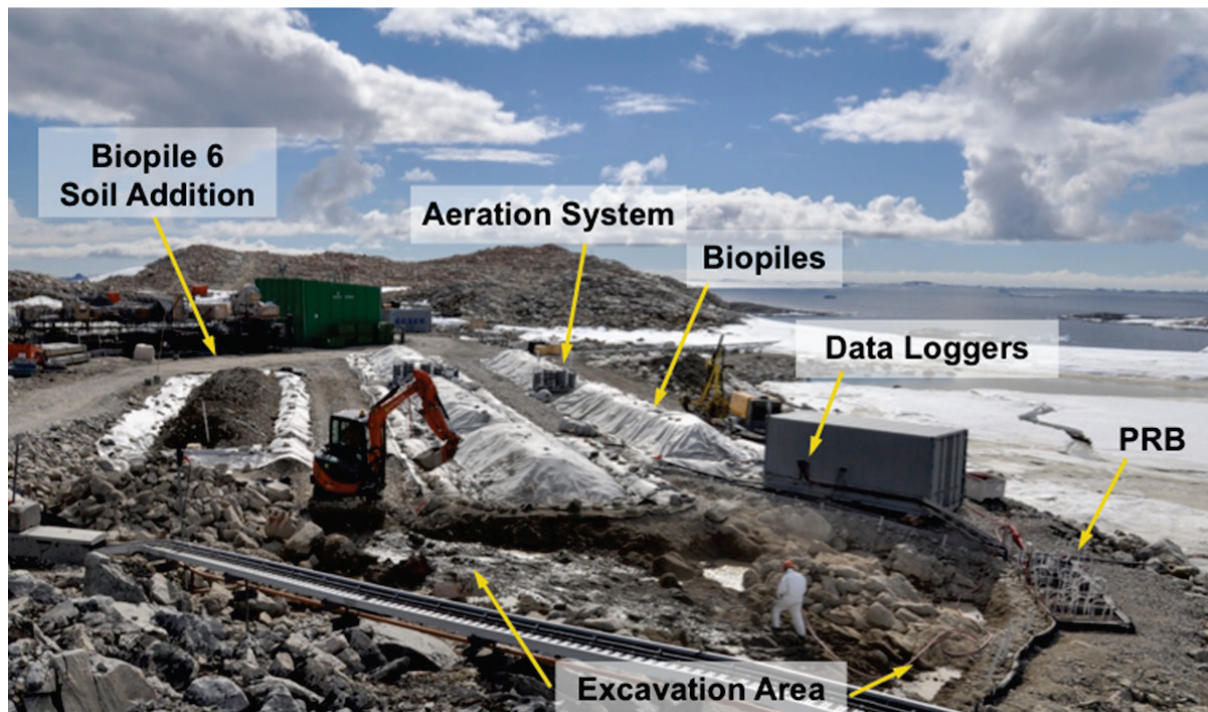
Figure 17. Remediation of fuel-contaminated soil using biopile and PRB (permeable reactive barrier) technology at Casey Station (Australian Antarctic Division). Construction site showing key features (ATCMXXXVIII-CEP6, 2015d).

In 2005 a remediation project was initiated following an oil spill at Casey Station (Australian Antarctic Division) in 1999 (ATCMXXXVIII-CEP6, 2015d). Before any remediation took place, investigations on natural biodegradation and evaporating rates were performed at the spill site concluding that the spill was almost unchanged even after five years in the Antarctic soil (Snape et al, 2006; Snape et al, 2005). Because the amount of contaminated soil was extensive and also located on a slope risking to leak contaminants into the sea, both biopiles and a permeable reactive barrier (PRB) filtering system were constructed (Fig. 17). Biopiles were amended with nutrients and aerated using a piping system. The piping system also functioned as a vapor extraction system for VOCs by applying vacuum to one side and drawing fresh air through the biopile, then leading the vapor filled air out through an activated carbon filter. After four years of operation the soil contained only one fifth of the original
